# CUMBERLAND AREA SCHOOLS

FEASIBILITY STUDY

JULY 12, 2011

COMPREHENSIVE FEASIBILITY STUDY OF:  
ALLEGANY HIGH SCHOOL  
BRADDOCK MIDDLE SCHOOL  
WASHINGTON MIDDLE SCHOOL

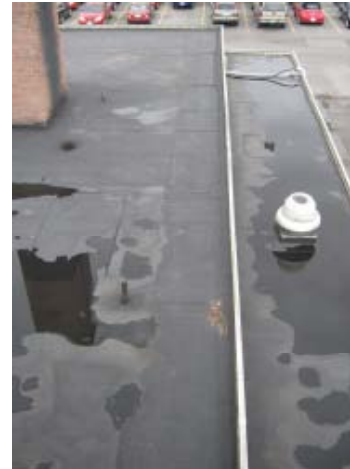
The existing roof is an exposed membrane roof which is in fair / poor condition and is beyond its warranty coverage. The majority of the roof plane is flat and there is evidence of significant ponding (see Appendix A, Photo 2&3). There are numerous soft spots in the underlying insulation and the majority of the insulation fasteners are telegraphing through the membrane. The existing aluminum coping and gravel stop are in fair condition. Through-wall flashing at low roof to wall transitions is copper and in fair condition, with no evidence of weep provisions. There are no overflow drains or scuppers provided.

**Photo 3** WMS - Roof-condition fair with ponding

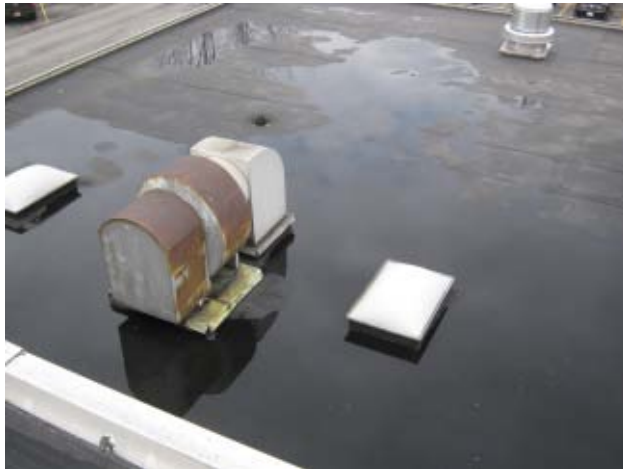
**Photo 2-** WMS - Roof-condition, fair with ponding

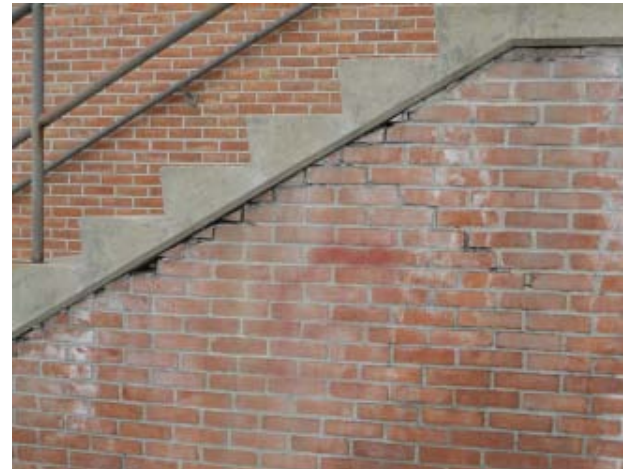
The building envelope consists of brick with CMU backup. The exterior masonry is generally in good condition, however, overall cleaning and some point up is required (see Appendix A, Photo 4). Most exterior sealants at control joints are in poor condition and should be replaced. There is evidence of cracking in several of the exposed concrete columns in the two story classroom wing (see Appendix A, Photo 5).

**Photo 4** WMS - Masonry – efflorescing, point up required

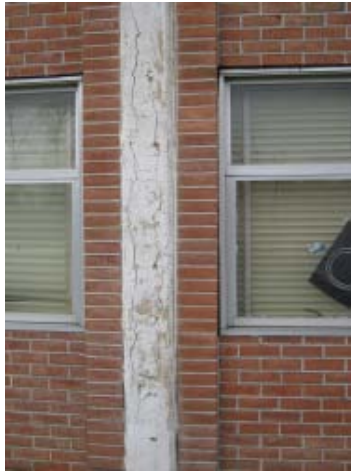
**Photo 5** WMS - Column cracking

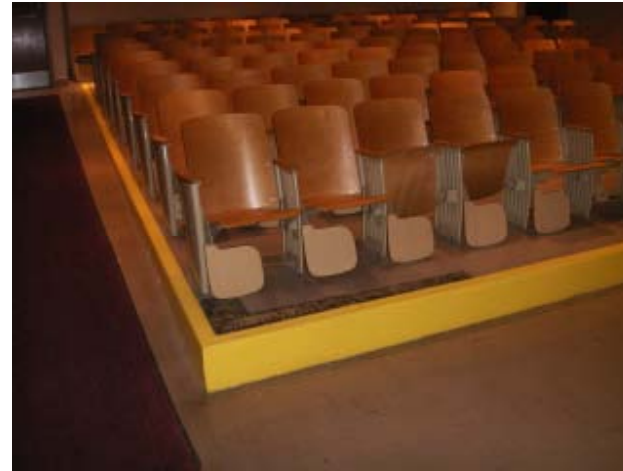
Most classrooms have the original 9 "x 9" vinyl asbestos tile (VAT) (see Appendix A, Photo 7), which should be replaced. Corridors are typically terrazzo which is in good condition. In some areas the VAT has been replaced with VCT, which is in good condition. Toilet rooms are typically ceramic tile. The gym wood floor is in good condition. The stage wood floor is in fair condition.

**Photo 7** WMS – Vinyl Asbestos Tile

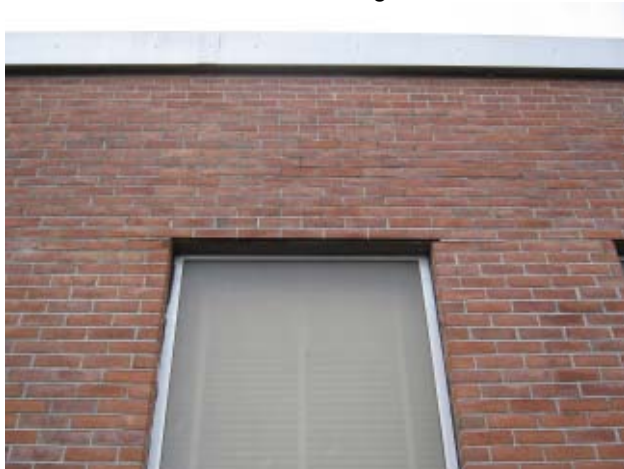
All exterior windows are single pane glazing which will not meet current energy standards and should be replaced with thermally broken insulated glass units. The windows also have deteriorating sealant which should be

replaced. Several lintels are rusting and should be repaired or replaced (see Appendix A, Photo 6).

**Photo 6** WMS - Exterior windows single glazed – rusting lintels

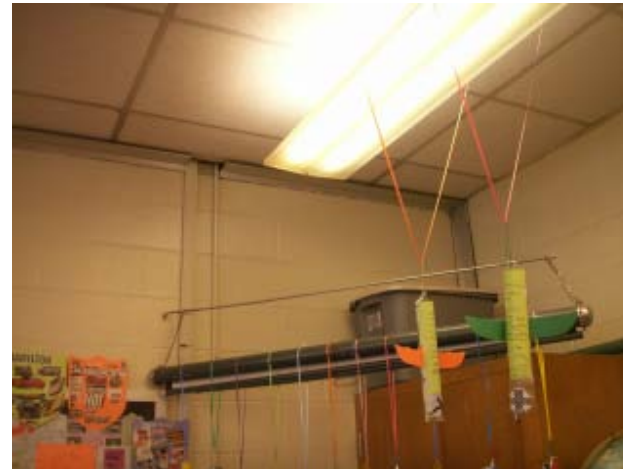
Most ceilings in the classroom building are suspended 2'x4' acoustic ceiling tile in metal grid and are in poor condition (see Appendix A, Photo 8). Tiles are damaged or stained and should be replaced. In some spaces the suspended ceilings have been replaced and are in good condition.

**Photo 8** WMS - Ceilings poor condition

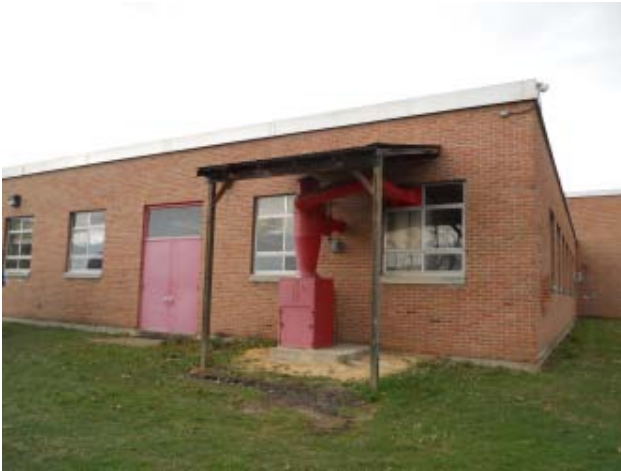
**Photo 9** WMS - Non ADA compliant entrance.

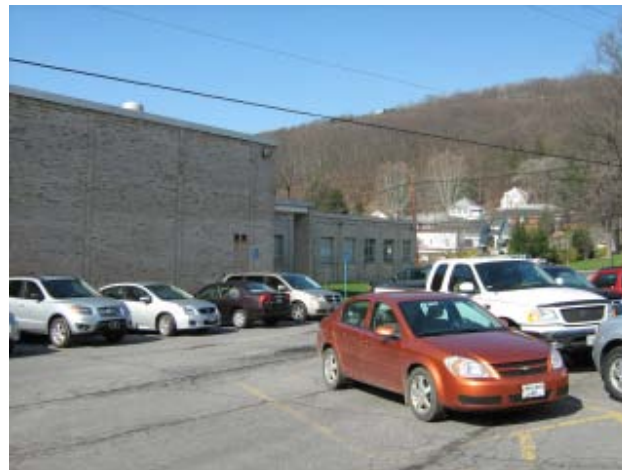
**Photo 16** BMS - Upper lot condition is poor

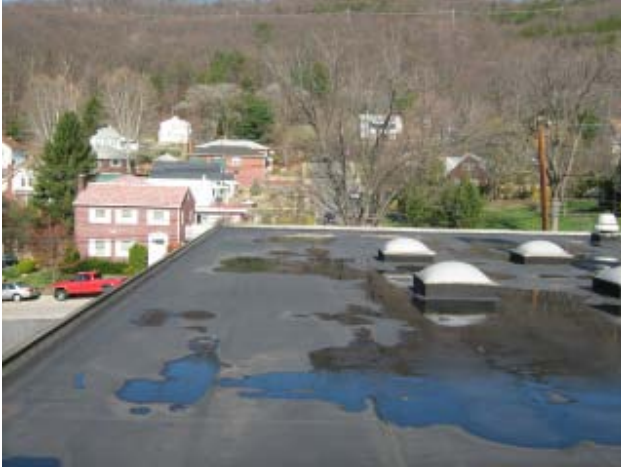
**Photo 17** BMS - Roof, fair condition with ponding

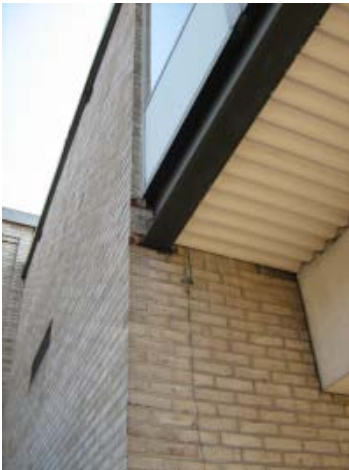
**Photo 18** BMS - Masonry – point up required

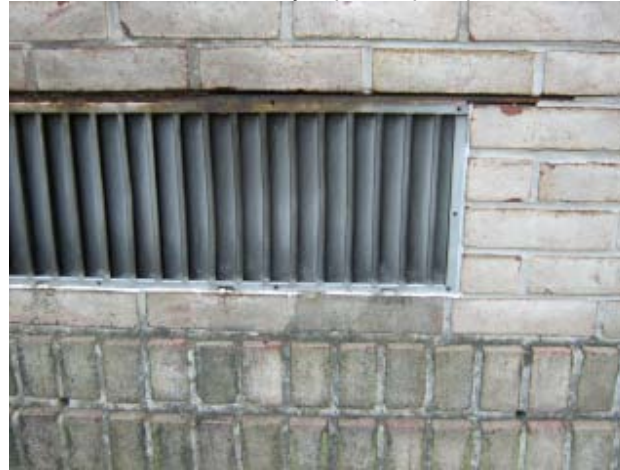
**Photo 19** BMS - Exterior rusting lintels

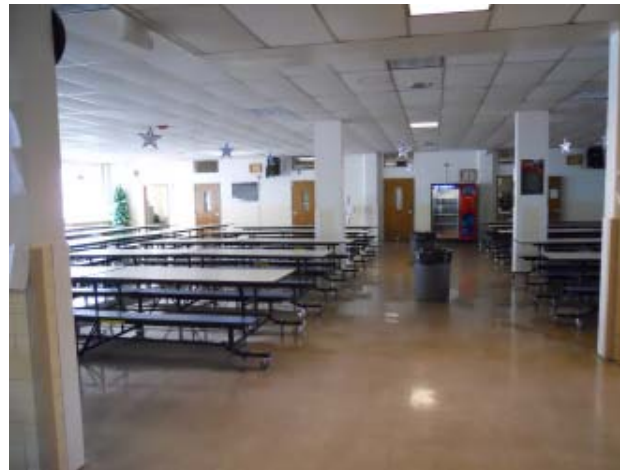
**Photo 20** BMS – Vinyl Asbestos Tile

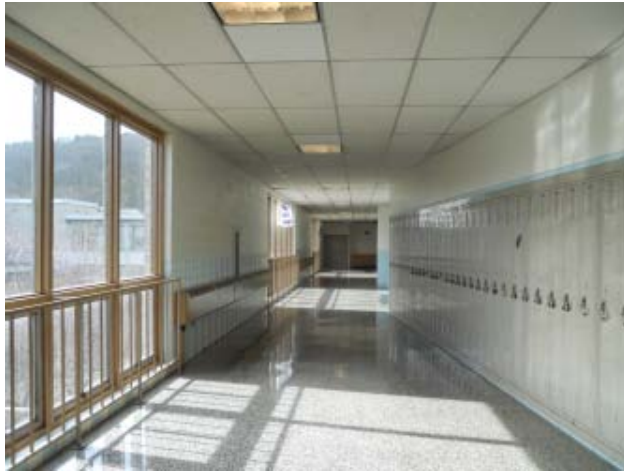
**Photo 21** BMS - Ceilings fair condition

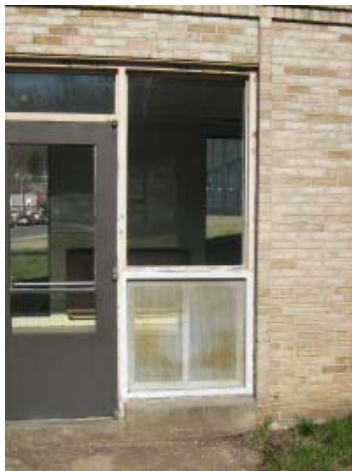
**Photo 22** BMS - Non ADA compliant entrance, wire glass lites

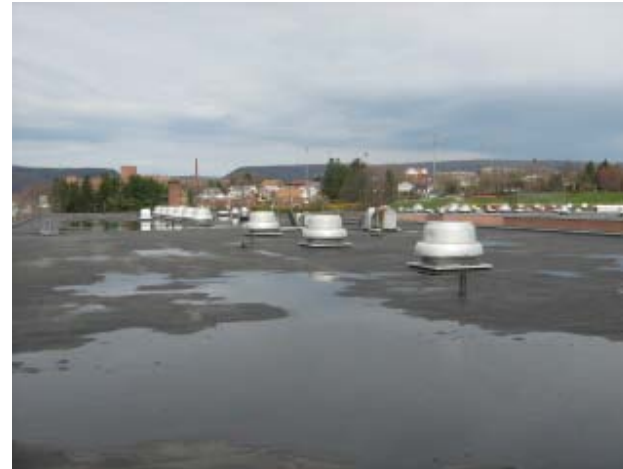
**Photo 27** AHS - Roof - fair condition, ponding.

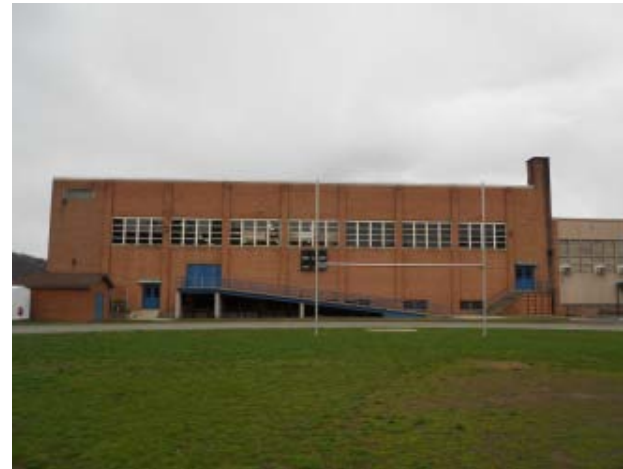
**Photo 28** AHS – Existing play fields are under-sized

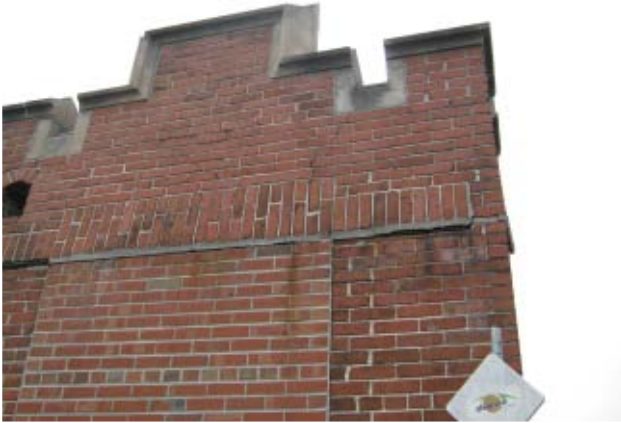
**Photo 29** – AHS masonry needs repair / repointing.

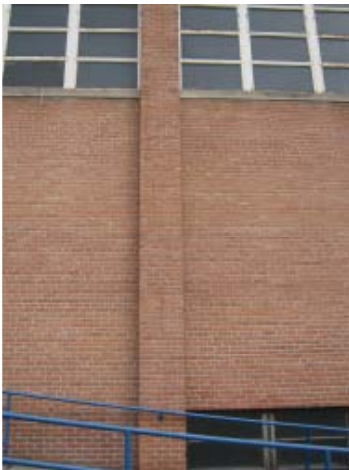
**Photo 30** AHS - masonry settlement cracking.

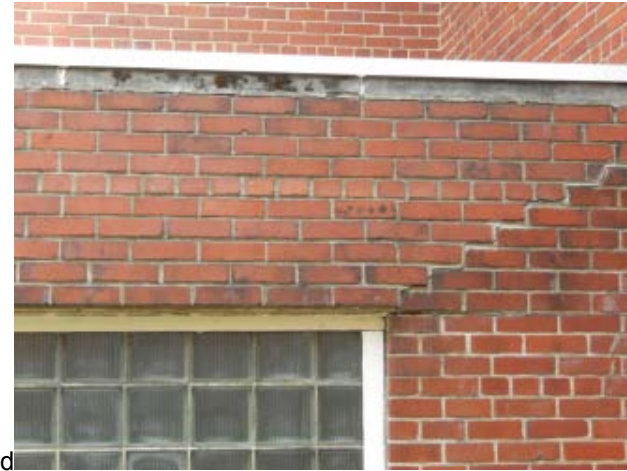
**Photo 31** AHS - masonry cracking from settlement.

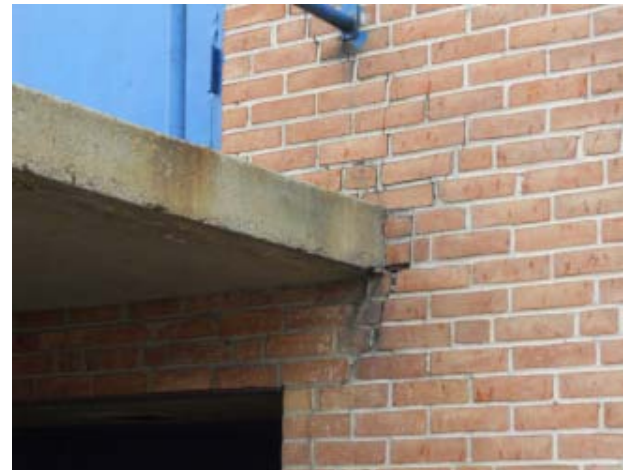
**Photo 32** AHS - Damaged masonry at canopy.

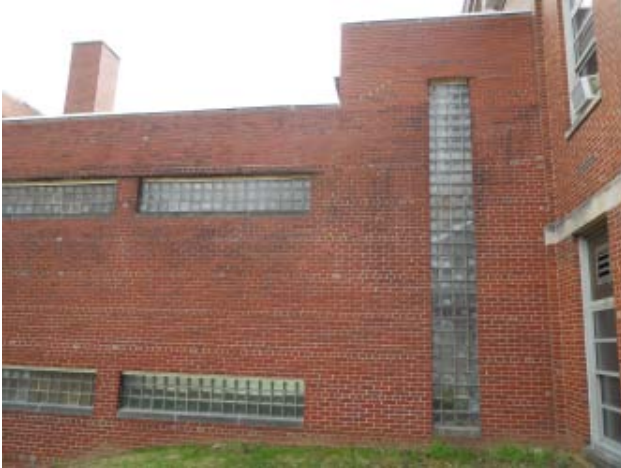
**Photo 33** AHS - masonry requiring minor repair

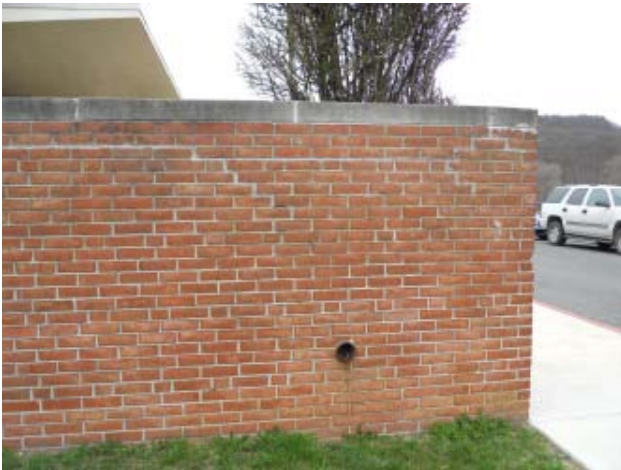
**Photo 34** AHS - Masonry – point up required

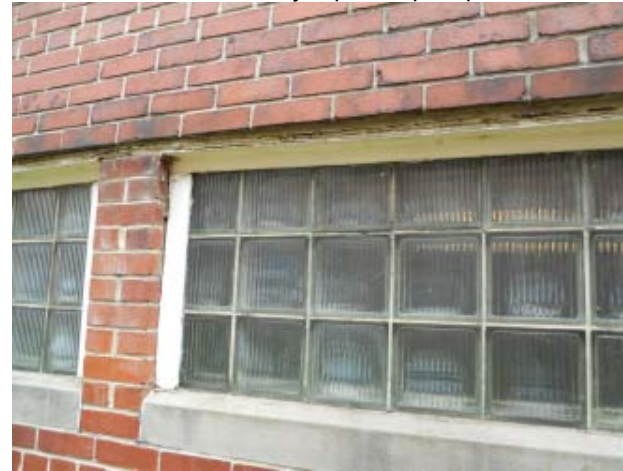
**Photo 35** AHS - Exterior rusting lintels

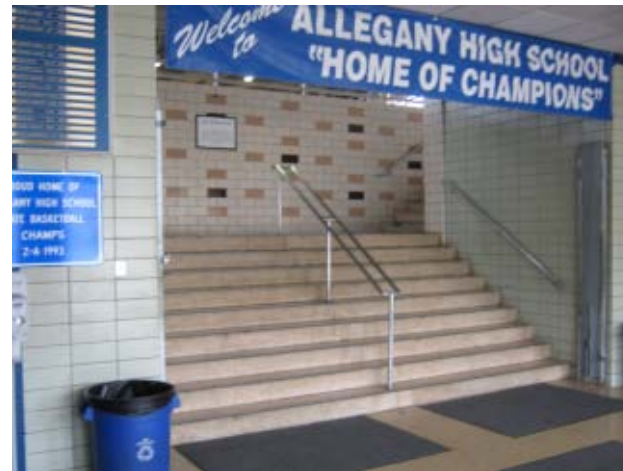
**Photo 36** AHS – Non-code compliant stair, high risers

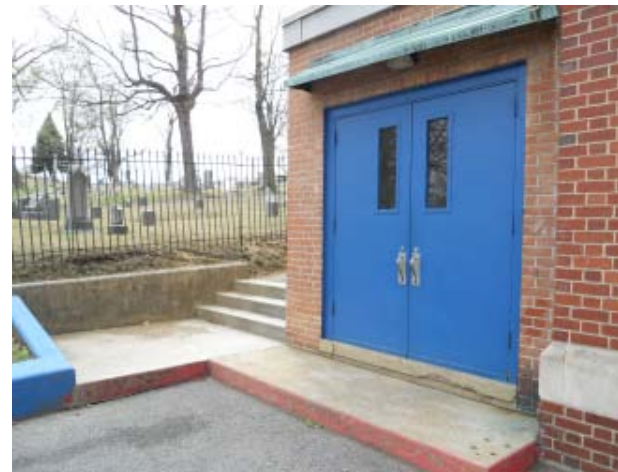
**Photo 40** AHS – Non-accessible entrance

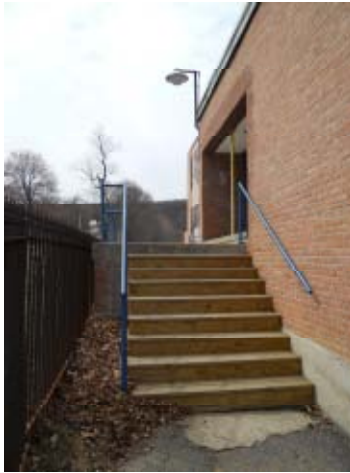
**Photo 41** Non-accessible stair
