COMPREHENSIVE FEASIBILITY STUDY OF

ALLEGANY HIGH SCHOOL AT THE *BRADDOCK HOSPITAL SITE*

GRIMM + PARKER ARCHITECTS

**CUMBERLAND AREA SCHOOLS FEASIBILITY STUDY
PHASE TWO**

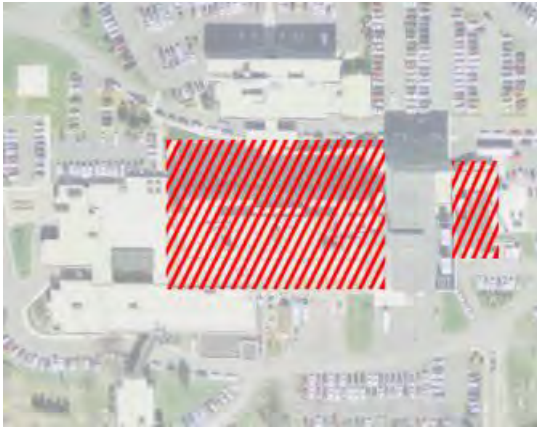
A. Main Hospital, 1967

The existing roof consists of a single ply membrane with ballast. The majority of the roof plane is flat with the exception of areas for skylights and at the location of the dome over the chapel. There is evidence of roof leaks in the upper levels.

All exterior windows are aluminum frame, single pane glazing which will not meet current energy standards and should be replaced with

thermally broken insulated glass units. Aluminum sun shading is provided on the existing hospital tower.

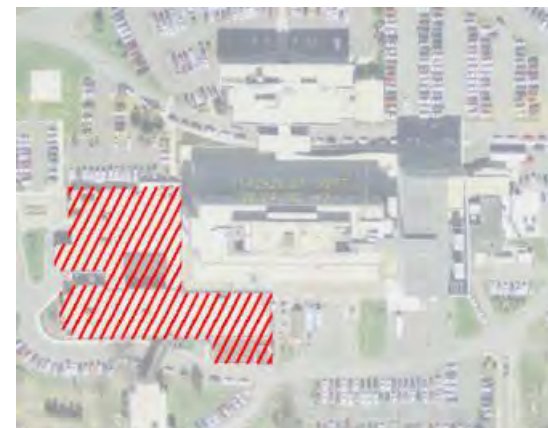
B. ICU/ED/5 North & Sisters Residence, 1990

The existing roof consists of a single ply membrane with ballast. There is evidence of roof leaks in the upper levels.

All exterior windows are aluminum frame, single pane glazing which will not meet current energy standards and should be replaced with thermally broken insulated glass units.

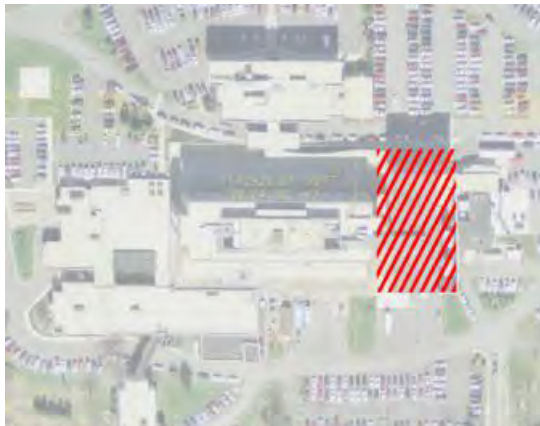
D. Annex, 2003

Floor consists of a variety of carpet and VCT throughout the different office areas with ceramic tile in the toilet rooms. All flooring is in good condition.

Interior walls are primarily painted gypsum board on metal studs with a few areas of vinyl wall covering. The walls around the stair towers are painted CMU walls. All the walls are in fair condition.

Ceilings consist of a variety of ceiling tile and gypsum board bulkheads. All are painted and in good condition.

All exterior windows are aluminum frame, single pane glazing which will not meet current energy standards and should be replaced with thermally broken insulated glass units.

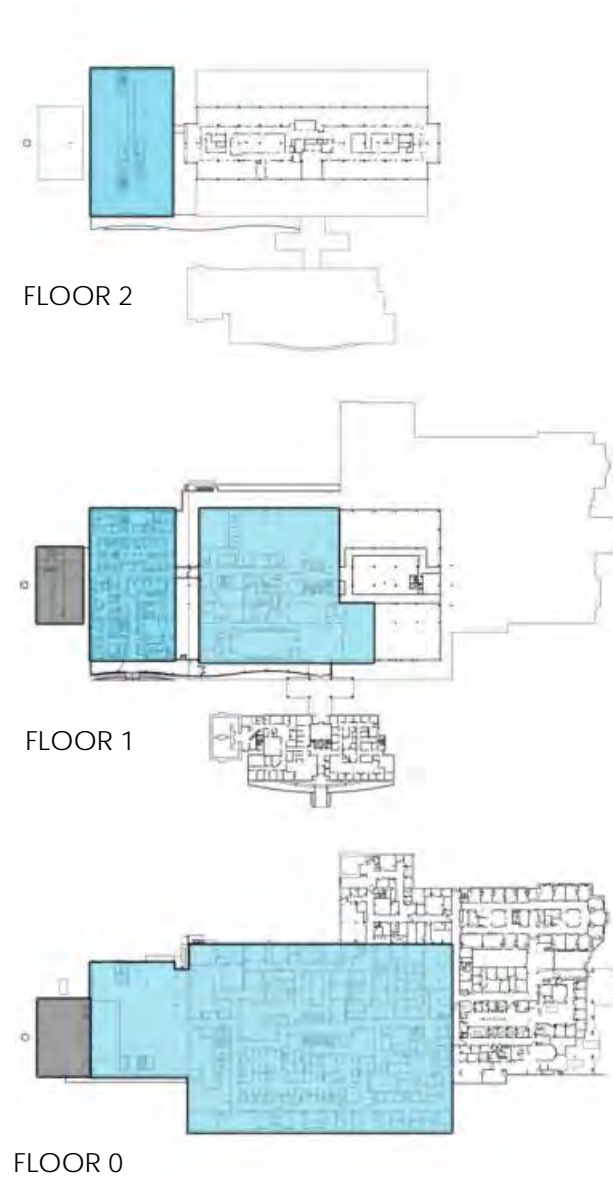
SCHEME 1 – FLOOR PLANS

145,830 Square Feet	Space for High School Program
171,172 Square Feet	Remainder Of Hospital Space
33,778 Square Feet	Mechanical Space

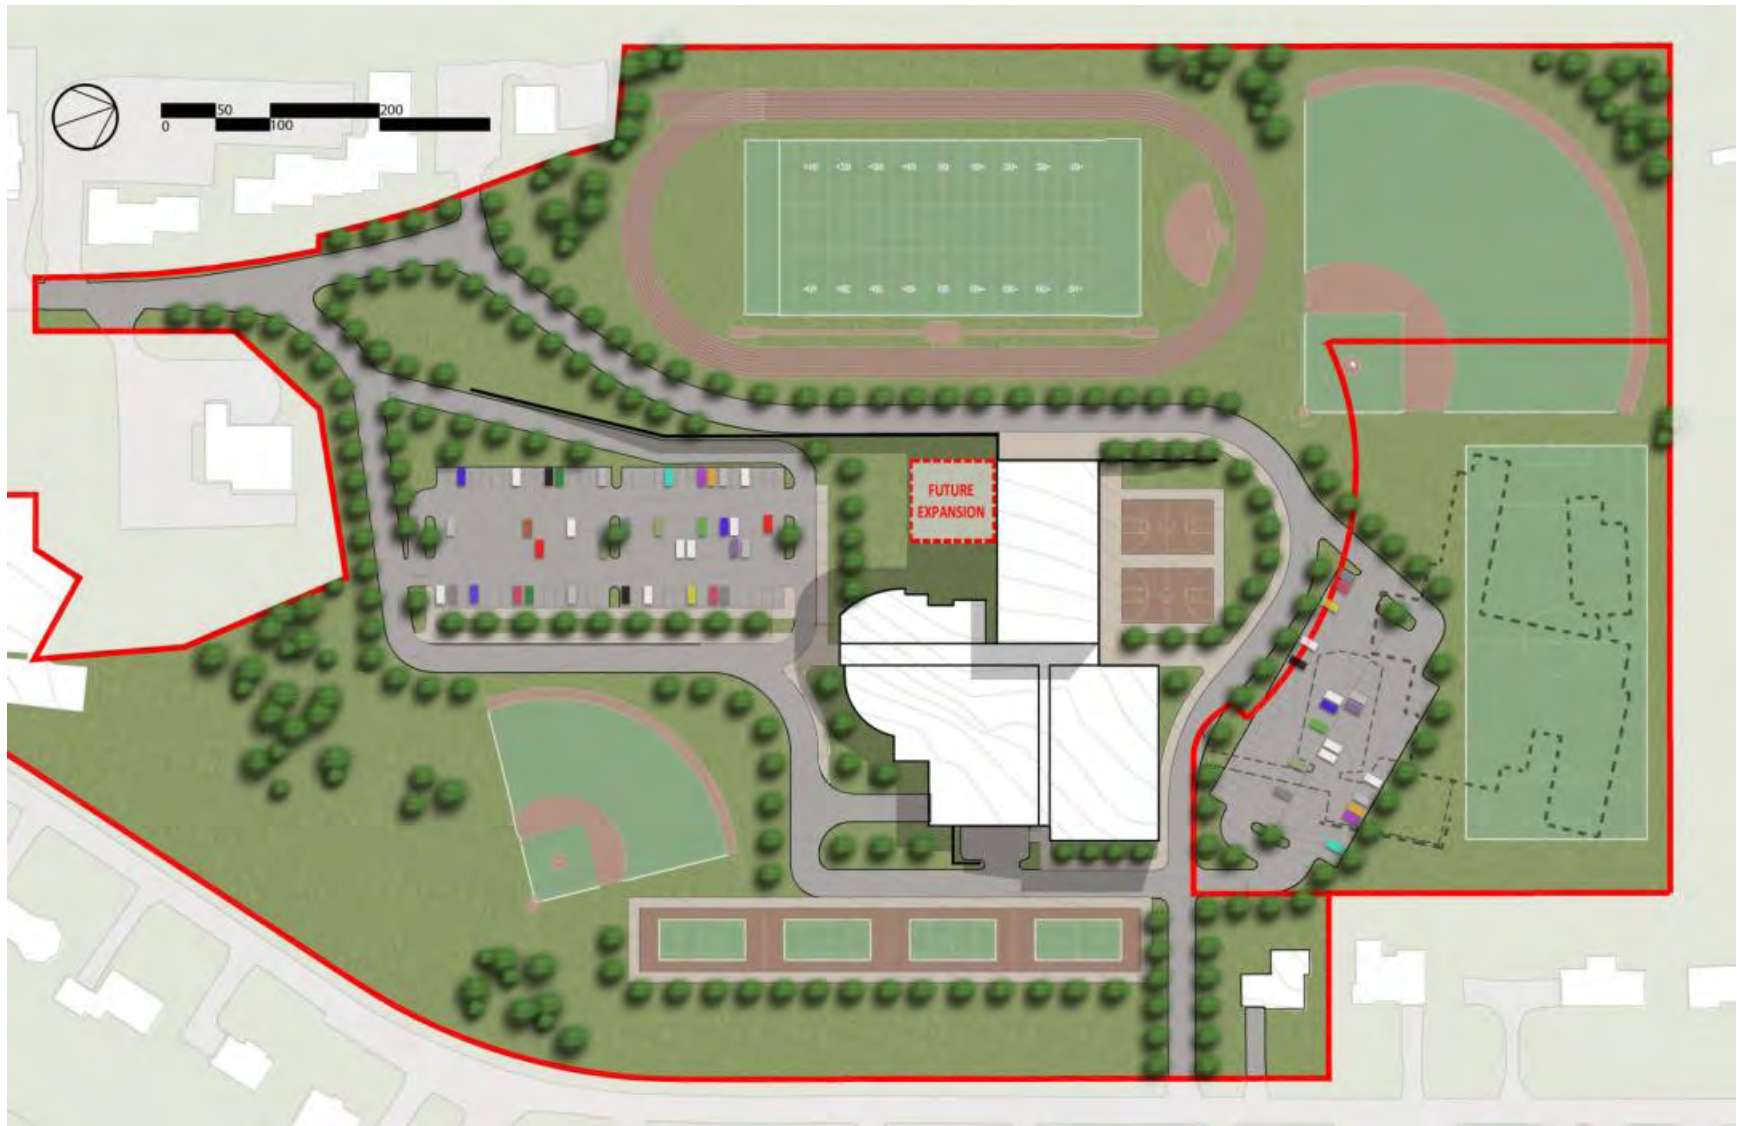
SCHEME 2 - SITE PLAN

SITE	<ul style="list-style-type: none"> • Provides ample space for parking in front of building • Bus loop separate from vehicle access • Fields are located in northern corner 	<ul style="list-style-type: none"> • Space with existing conditions (assisted living facility) not adequate for a baseball field • Existing Assisted living facility impedes parking spaces on site

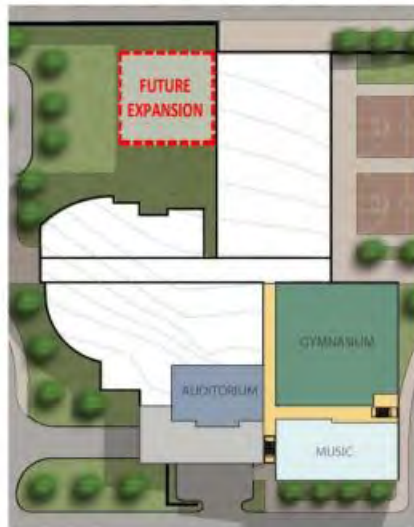
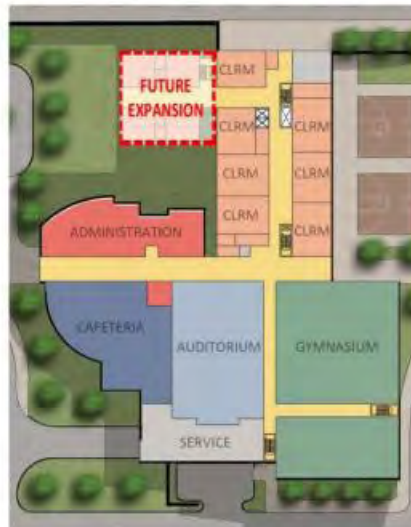
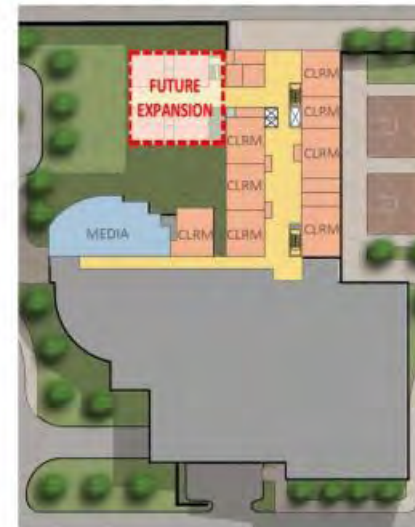
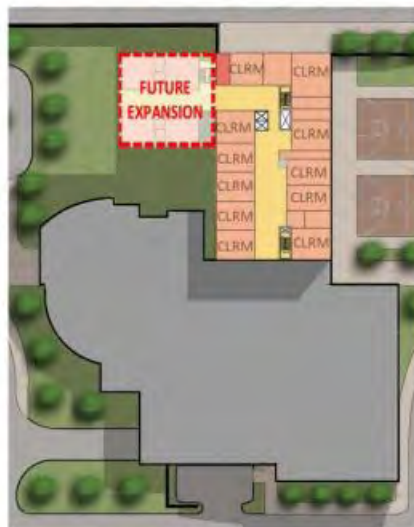
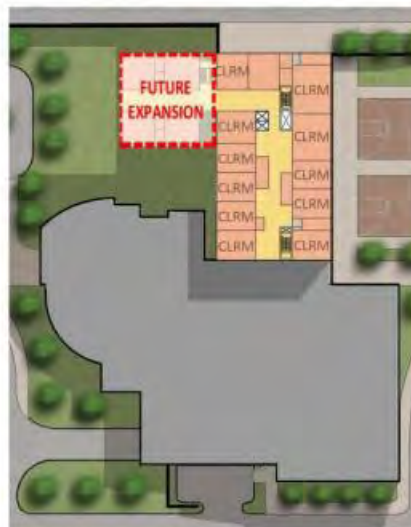
SCHEME 2 – FLOOR PLANS

Several options were explored where the Diagnostic Annex tower was retained and reprogrammed for use as part of the new high school building. It was determined that due to the newness of the building and the configuration of the structure, this portion of the existing hospital would have value to the new school building. The scheme shown below is the most successful scheme based on this premise. The Diagnostic Annex tower was found to be in good condition and therefore worthy of reuse but due to the design of the building almost all building systems would need to be replaced so that systems appropriate to a high school building could be provided. This scheme is based on a total student capacity of 857. It was found to not save cost over the design of a new facility.

One of the factors affecting the cost of this scheme is its inefficiency. Since the proportions of the Diagnostic Annex tower are not ideally suited of a school, some efficiency is lost in this design, resulting in a greater square footage overall cost. Also, in order to allow light into the classrooms located in the tower, the new construction to the east of the tower, cannot take advantage of the reuse of the existing foundations.

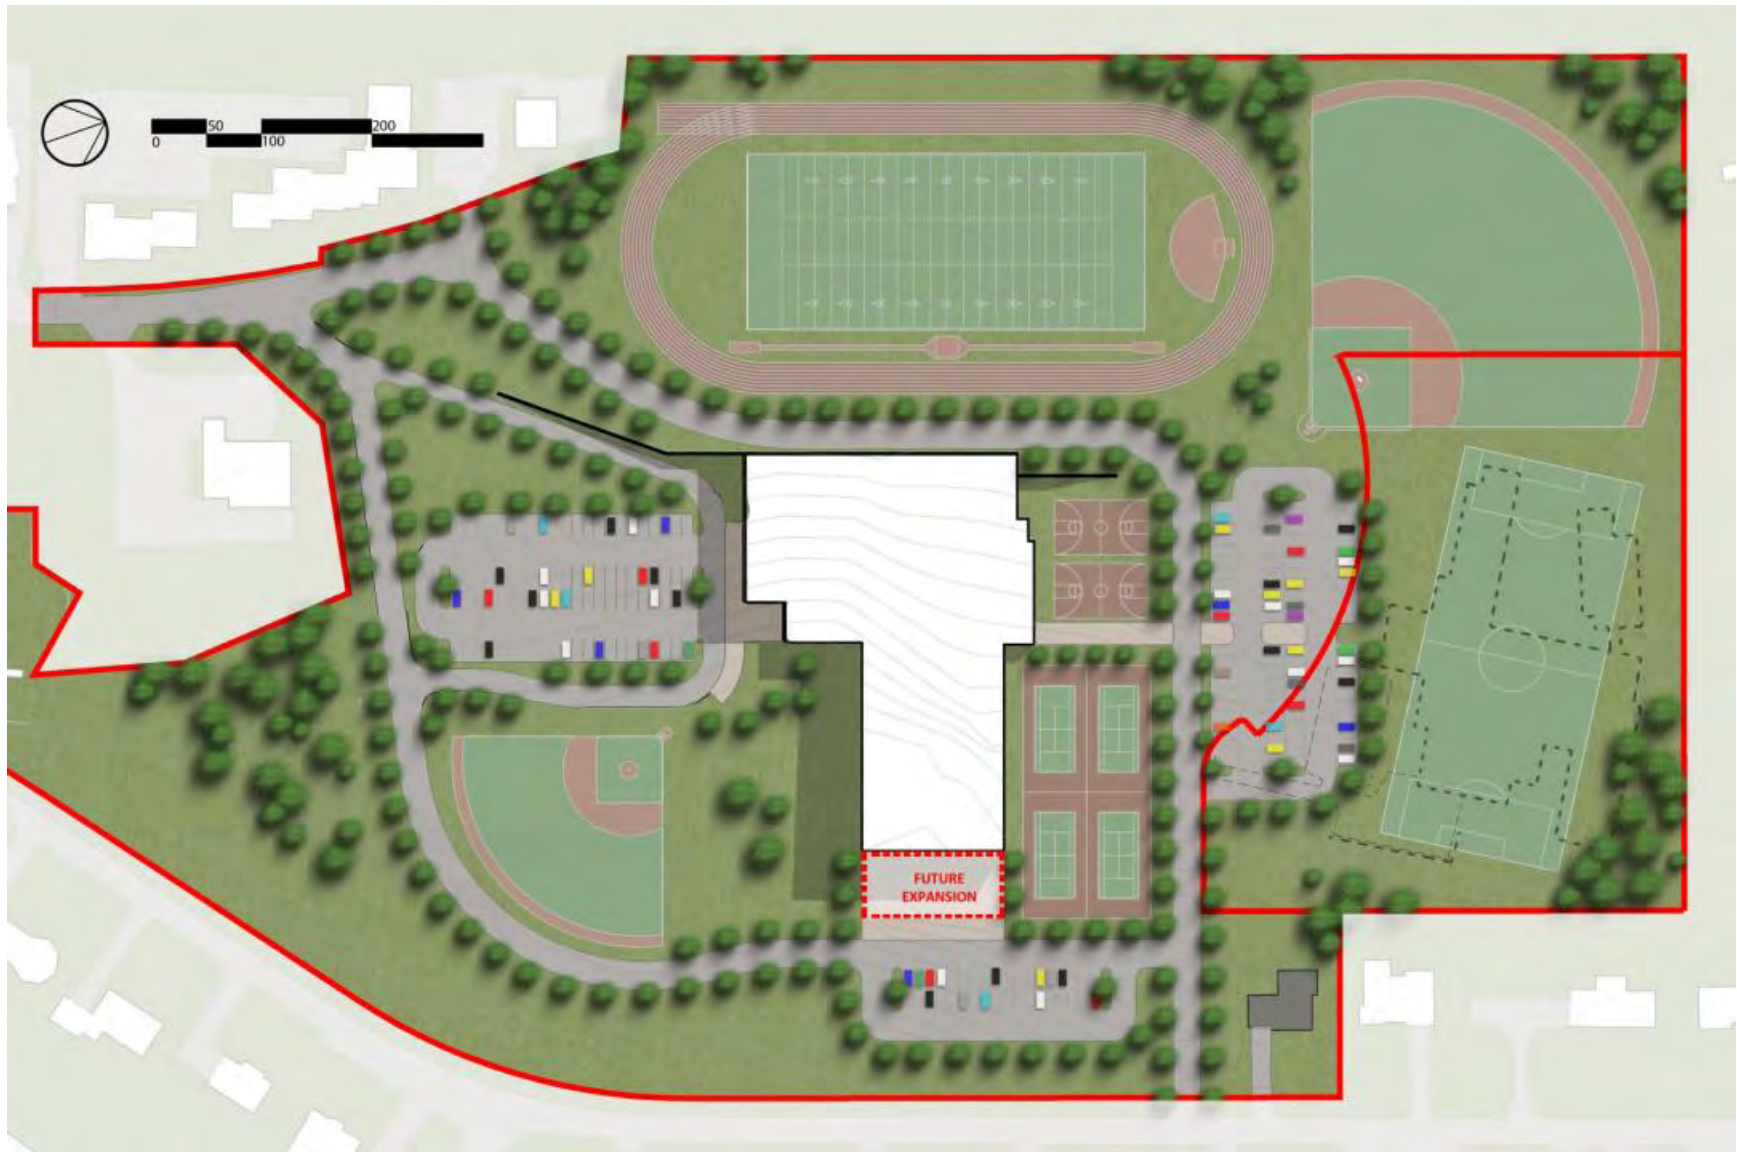
SCHEME 3A – SITE PLAN

In this scheme, a new building is constructed in the location of the existing structure. The large two story volumes in the program are located against the existing retaining wall to make use of the existing remaining wall.

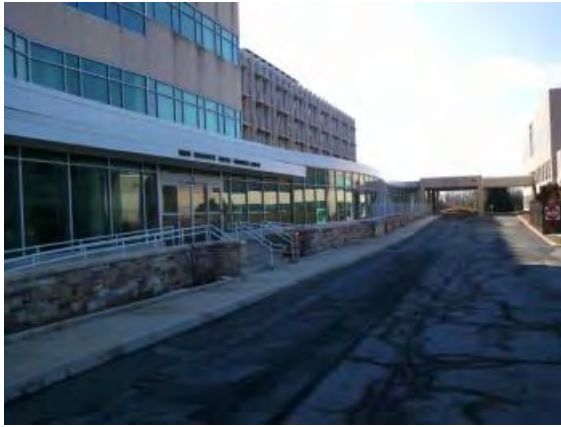
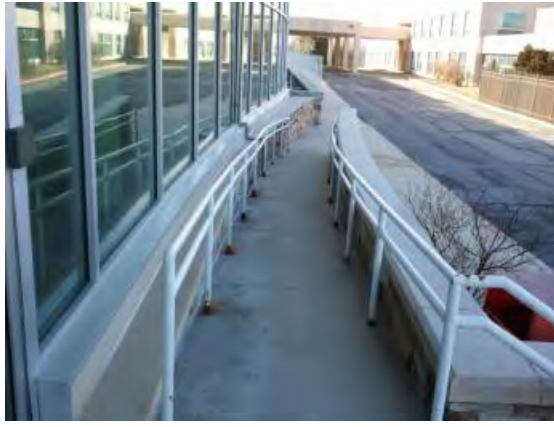
Entrance at Diagnostic
Annex Tower

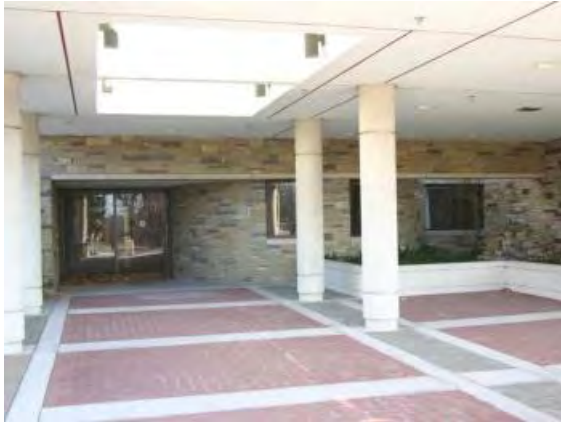
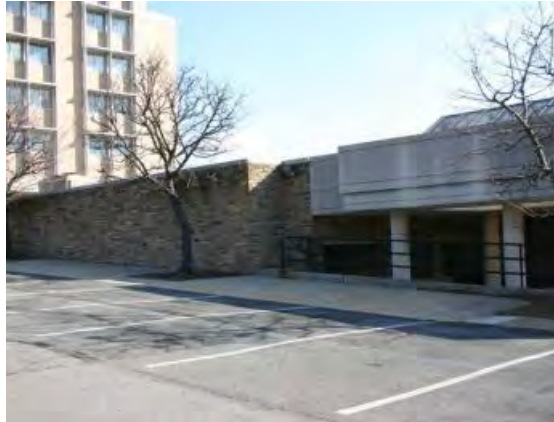
Entrances at emergency
department

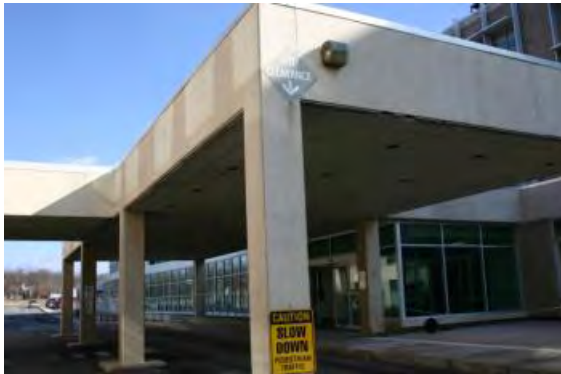
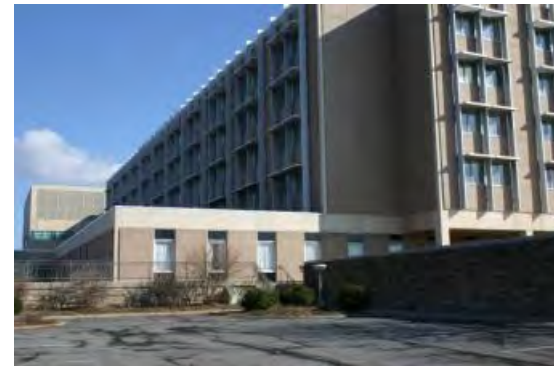
Covered drop off at
hospital entrance and
medical office building

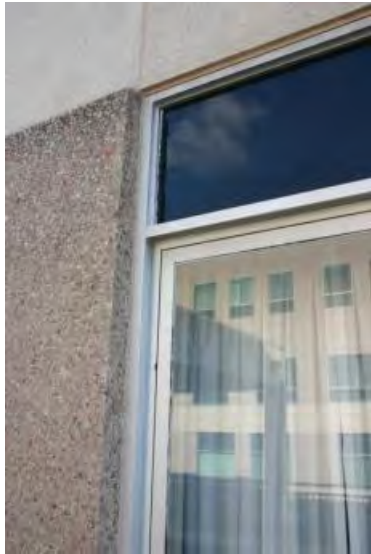
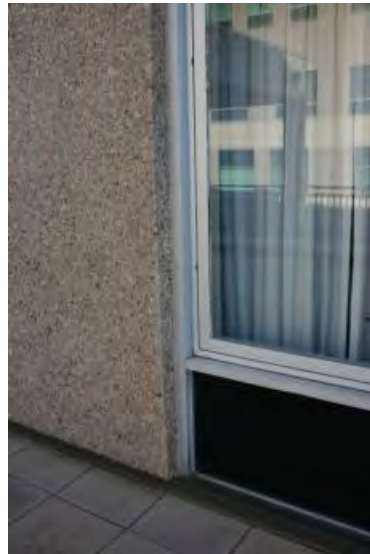
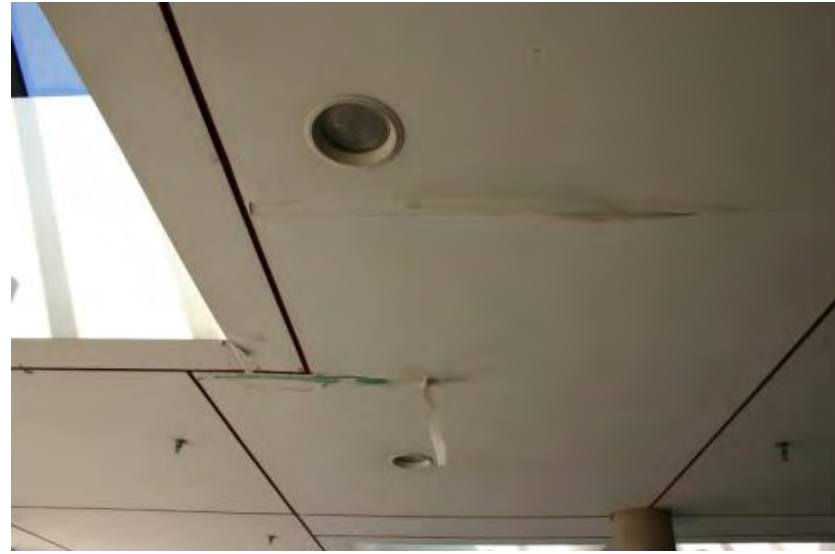
Exterior conditions at windows, and canopies at the main hospital building

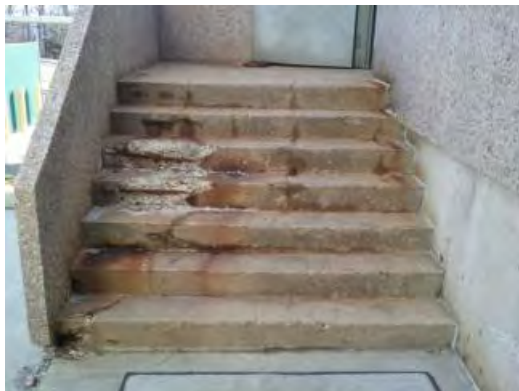
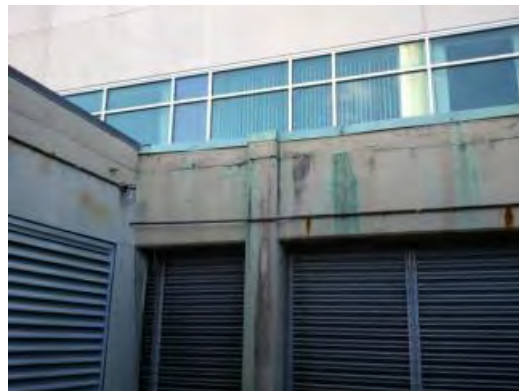
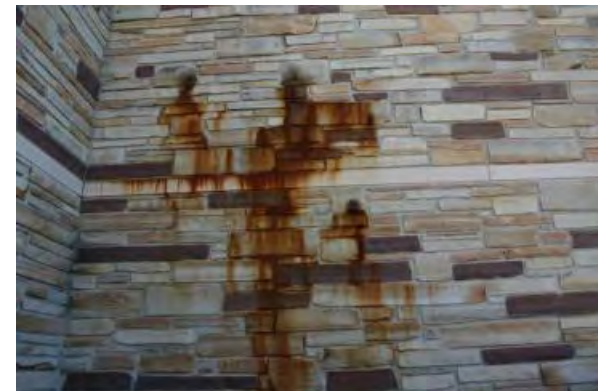
Exterior condition in service areas of main hospital building, Diagnostic Annex Tower, and Emergency department

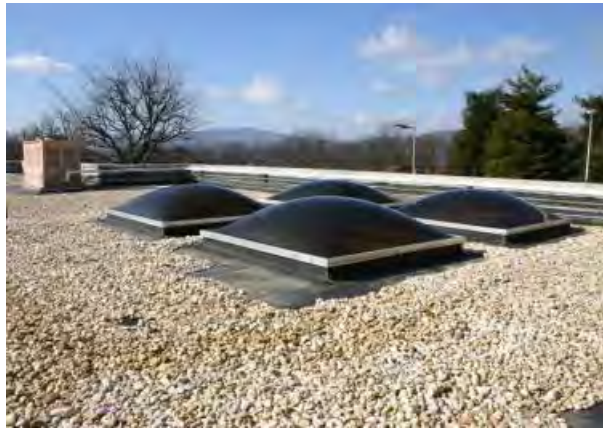
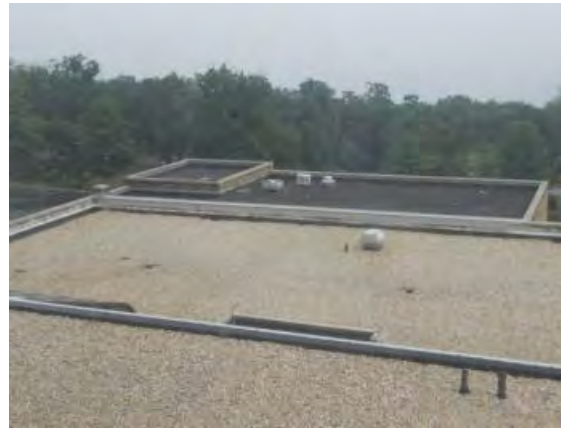
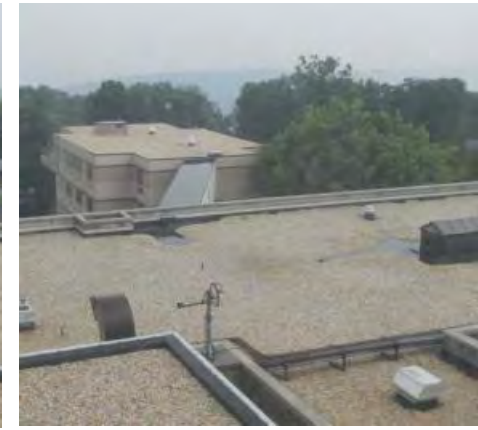
Ballasted roof over Emergency Department / Intensive Care Unit

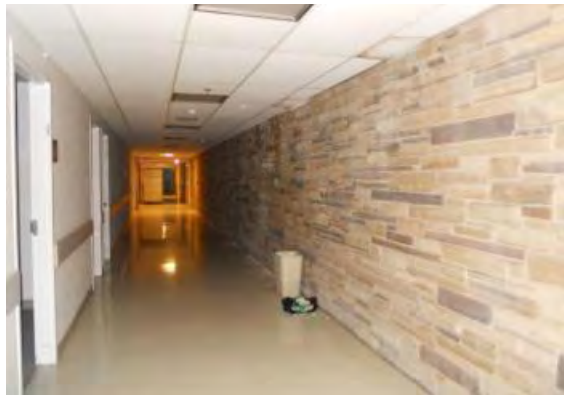
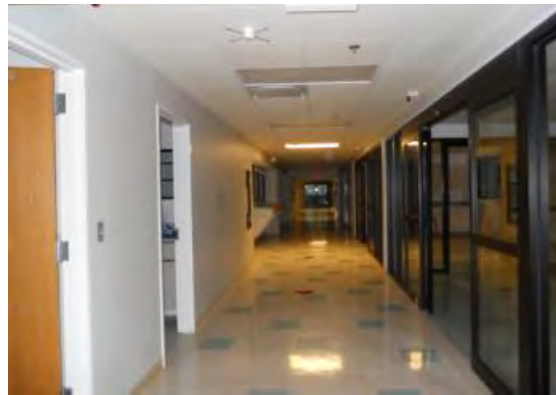
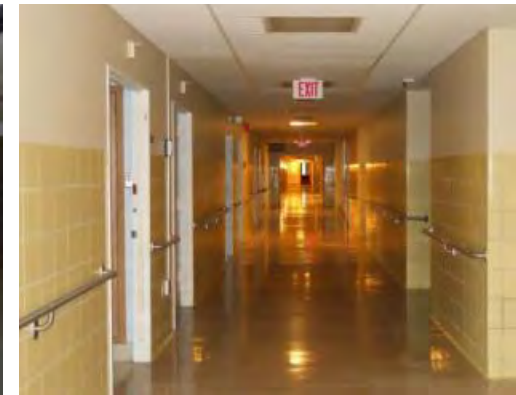
Existing corridors within Main Hospital, Emergency Department, and Diagnostic Annex Tower
