# CUMBERLAND AREA SCHOOLS

FEASIBILITY STUDY

JULY 12, 2011

COMPREHENSIVE FEASIBILITY STUDY OF:  
ALLEGANY HIGH SCHOOL  
BRADDOCK MIDDLE SCHOOL  
WASHINGTON MIDDLE SCHOOL

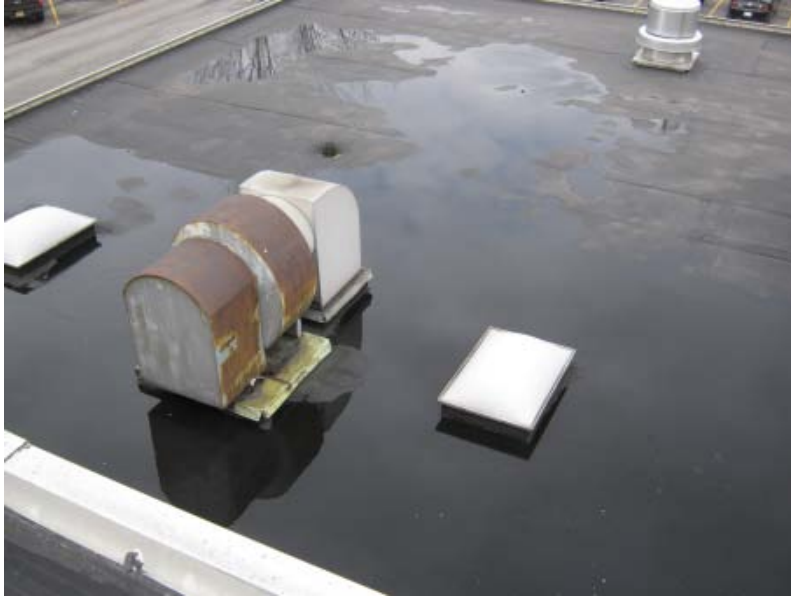
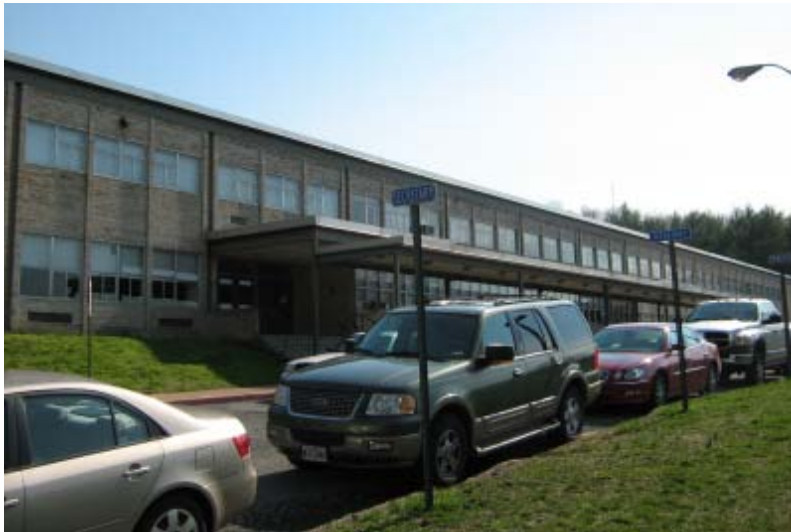
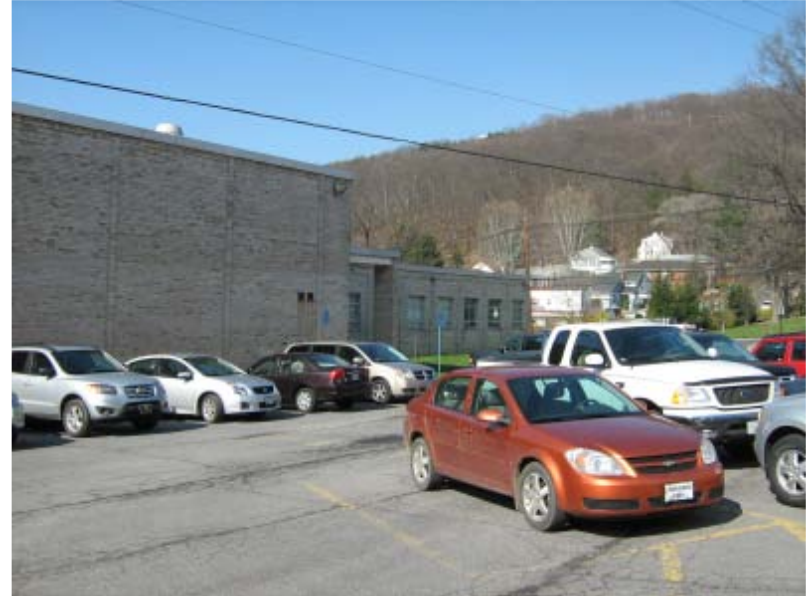
Service access is provided via an alley to the rear of the site. A small barely functional loading dock is adjacent to the access to the cafeteria. Any multi-part or long-wheelbase delivery vehicle would need to back into the loading area from Tilghman Street.

The school has two defined pedestrian routes consisting of paved sidewalk. Pedestrians can approach from the west via Sedgwick or from the east via Tilghman Street. The routes are not fully accessible. The condition of the sidewalk along both streets varies. Isolated repair or total replacement should be anticipated.

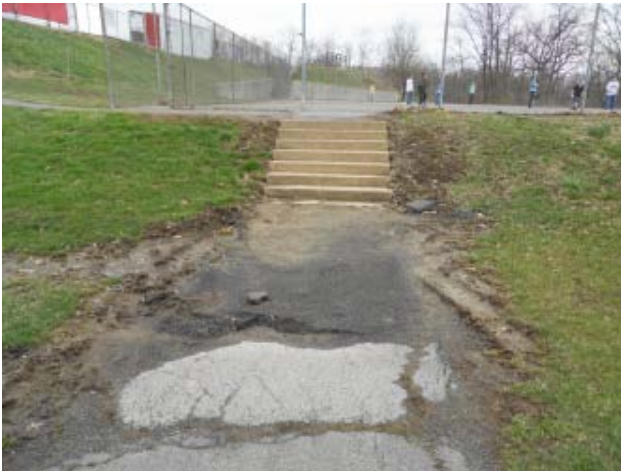
Reasonable access among the components of the site is provided. However, most of it does not meet ADA requirements (see Appendix A, Photo 10). None of the athletic or play areas have an accessible route to the school.

**Photo 10** WMS - Non-ADA compliant pathway to playground.

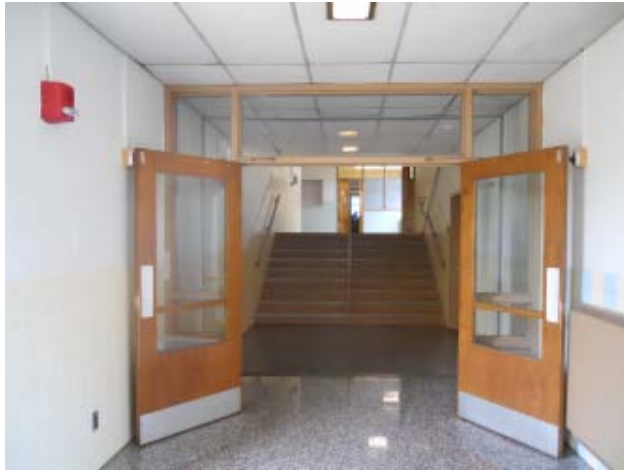
**Photo 13** – BMS - Non-ADA compliant at Stair

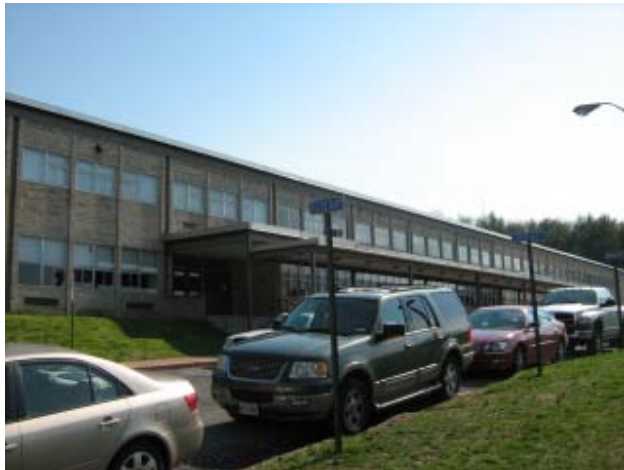
Parking is provided along Franklin Street and in a parking lot on the upper plateau. The parking along Franklin Street does not meet ADA requirements (see Appendix A, Photo 14). There is no accessible route found from the parking spots (most of which are dedicated to staff) to the main entrance to the school. There is a covered waiting area that includes benches opposite of the parking. The upper lot is not accessible in its current state but could easily be made so. The physical condition of the upper lot is poor (see Appendix A, Photo 16). There are areas where the asphalt has all but disappeared, creating an uneven and dangerous walking surface. In addition, the curb line adjacent to the building has deteriorated to a point where it no longer adequately conveys water or serves as a traffic barrier. Any renovation should consider completely rebuilding and enlarging the lot. The condition of the lot does not appear readily salvageable.

**Photo 14** BMS - Non-ADA accessible parking - Franklin Street

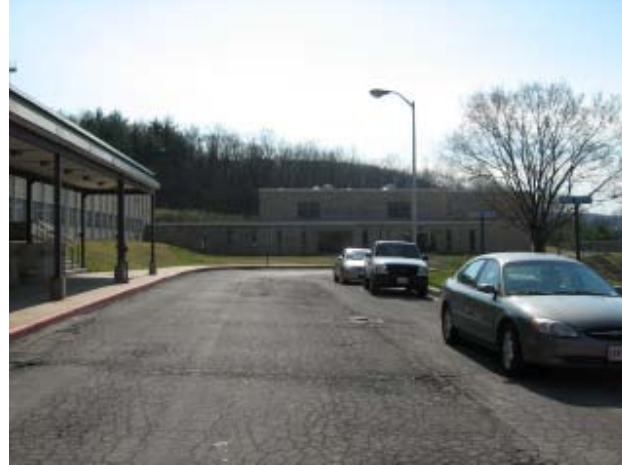
Franklin Street is currently in a state of disrepair. There are several areas where pavement failure is indicated. Any renovation scenario should consider rebuilding Franklin Street including significant subgrade repair. Pavement cracks with water seepage through those cracks indicate potentially serious issues with groundwater and drainage along this street (see Appendix A, Photo 15).

**Photo 15** BMS - Water seepage on Franklin street

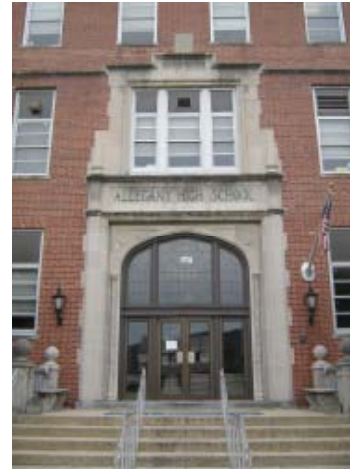
**Photo 23** AHS - Previous main entrance altered to window opening.

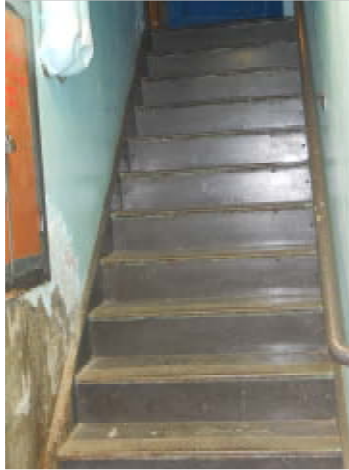
**Photo 37** AHS - Non-ADA compliant stair.

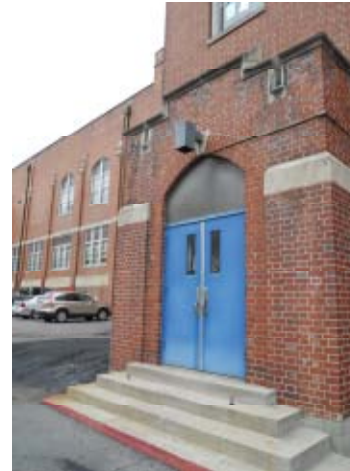
**Photo 39** AHS – Non-ADA compliant entrance
